Navajo Abandoned Uranium Mine

Site Screen Report

Charles Huskon No. 11 AUM Site

Weston Solutions, Inc.

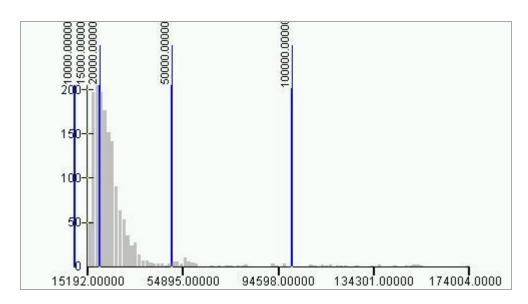
The following chart and statistics were generated by ESRI ArcGIS 9.3.1, and show the general distribution of the site gamma radiation measurements. The horizontal X axis represents the gamma radiation reading levels in cpm (lowest levels to the left). The vertical Y axis represents the frequency of each gamma radiation level.

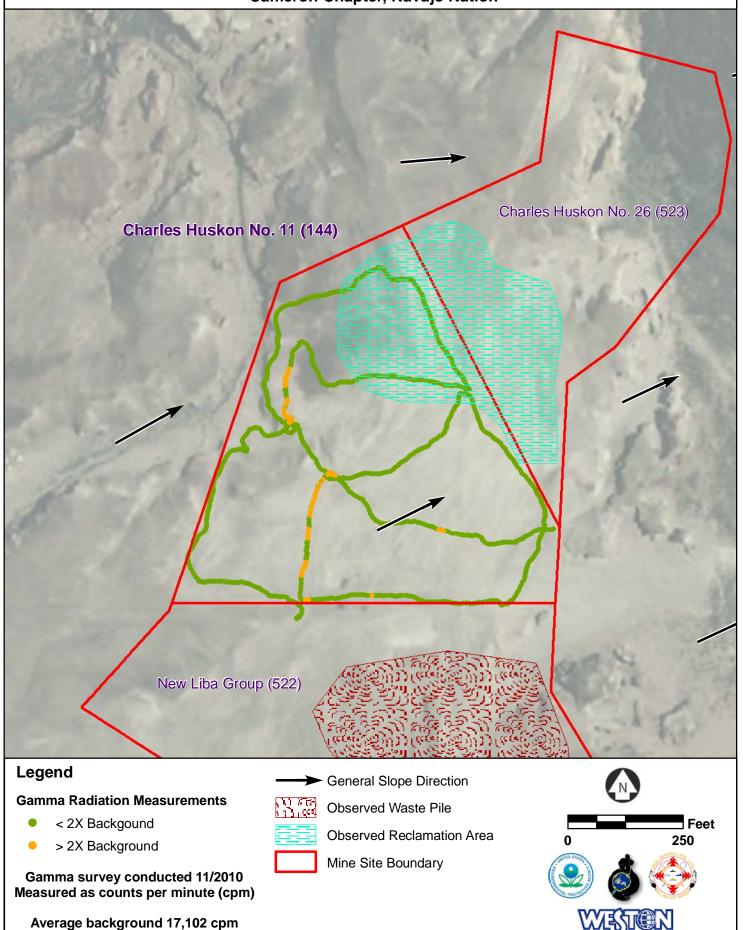
Figure 1 - Gamma Radiation Measurements, Above Two Times Background
Charles Huskon No. 11 (144)
Cameron Chapter, Navajo Nation

A total of 1,556 gamma radiation measurements were collected from the mine site, ranging from 15,192 cpm to 174,004 cpm. The measurements collected at the reclamation area were found at maximum levels ranging from approximately 25,000 cpm to 40,000 cpm, and at an isolated hot spot in the center of the site at a maximum level of approximately 175,000 cpm. The measurements are represented in Figures 1 and 2.
